Location: Ethiopia

## 21 - Cattle path stabilization

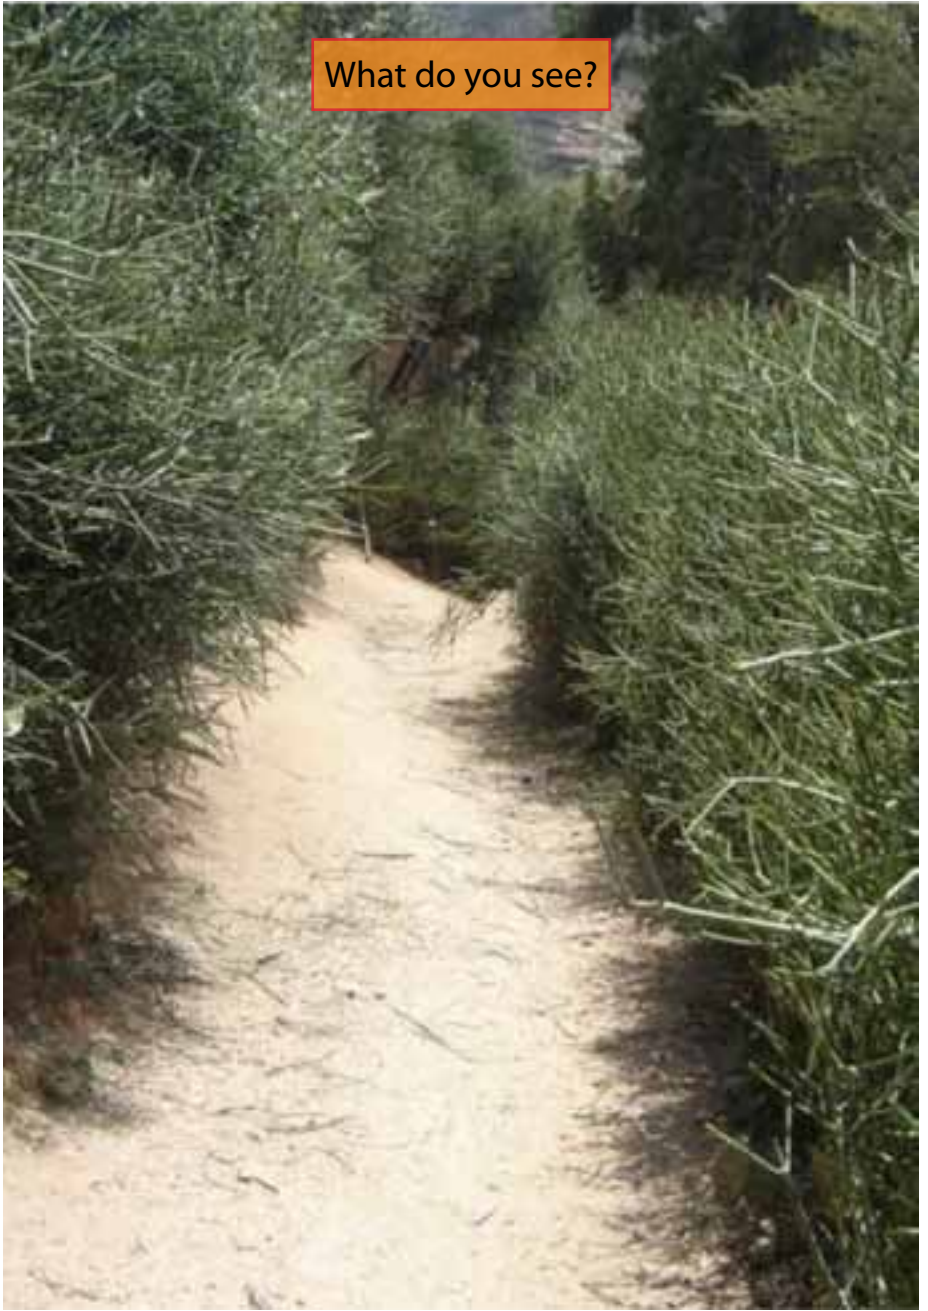
This Eroded path was stabilized with bushes of Euphorbia Tirucalli.

Fast growing plants that provide good soil cover and have a deep rooting system are preferred because they can stand harsh conditions and be effective quickly.
